ASSESSMENT OF THE CORROSION OF COPPER COMPONENTS IN THE WATER COOLING SYSTEM OF ALBA SYNCHROTRON LIGHT SOURCE; PRESENTATION OF A PROPOSAL TO MITTIGATE THE CORROSION RATE OF COPPER

M. Quispe[†], E. Ayas, J.J. Casas, C. Colldelram, M.Ll. Fuentes, J.C. Giraldo, J. Iglesias, M. Pont
ALBA – CELLS Synchrotron, Cerdanyola del Vallès, Spain
J. Buxadera, M. Punset, Universitat Politècnica de Catalunya, Barcelona, Spain

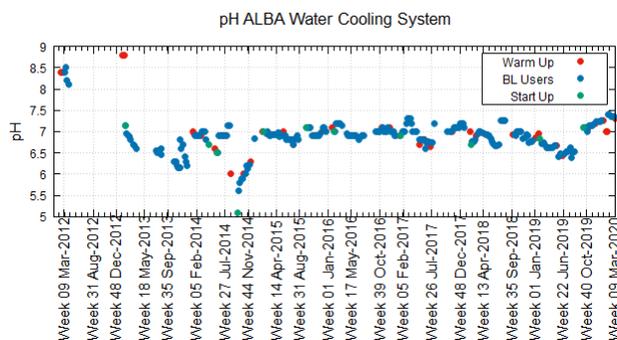
The pH is one of the main parameters involved in copper corrosion. As a practical number, it is recommended to have the water with a pH above 7.5. In Fig. 2 the evolution of the pH in ALBA is represented for the last 9 years. According to this result, most of the time the average pH value has been 7, but irregular values of 5.5 to 6.5 are reported for the years 2013 and 2014. Very high pH values (between 8 and 8.5) have also been found during the year 2012. It is assumed as a hypothesis that the pH data in the first years have been affected by problems in the instrumentation.

Figure 2: PH values in the ALBA deionized water cooling system, for the period 2012 to 2020. The data are weekly average values.

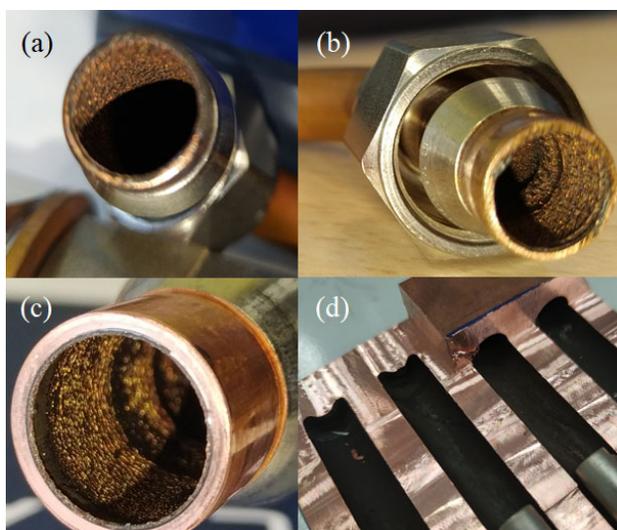
In the first visual analysis, high roughness was observed on the internal surfaces of the samples, such as the example in Fig. 3a, 3b and 3c, corresponding to samples S4, S3 and S5. In other cases, such as in Fig. 3d, the surfaces were characterized by having a smooth morphology, with a brown dark colour, indicative of the formation of oxide layers. In various parts of the system, deposits of oxide particles have been found, presumably they are copper oxide particles.

Figure 3: Images of four samples under study: Copper Masks of the Front Ends (a) BL13 and (b) BL11, (c) Copper Radio Frequency Cavity and (d) Glidcop Al-15 Crotch Absorber.

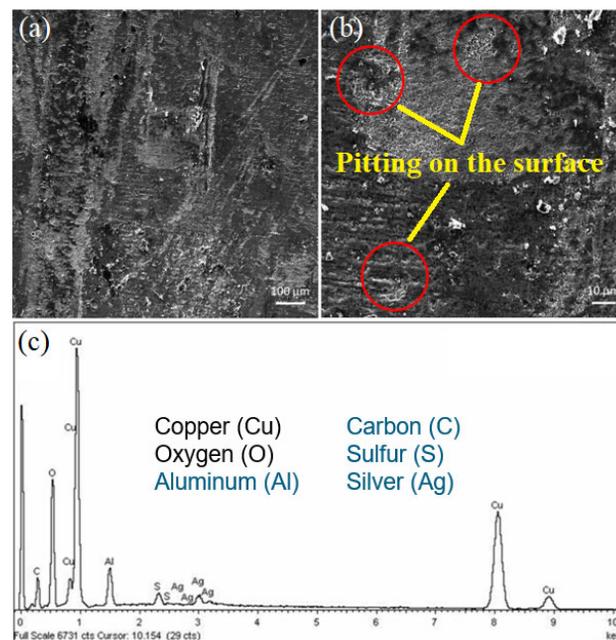
The samples S1, S2, S3, S4 and S5 show pitting corrosion on their surfaces (see example of Fig. 4b, sample S1). In addition, the samples S1, S2, S3 and S4 show generalized corrosion. As a particular case, the sample S5 exhibits intergranular corrosion. In some regions of samples S1, S2, S3, S4 and S5 the EDS analysis has confirmed the presence of Copper, Oxygen, as well as other elements such as Sulfur, Silver, Chlorine and Calcium (see example of Fig. 4c, sample S1). The cross-sectional analysis of samples S1, S2, S3, S4 and S5 has determined the pit depth, with values between 3.84 and 101.5 μm . The XRD analysis has confirmed the presence of copper oxide on the inner surface of samples S1, S2, S3, S4 and S5.

Figure 4: Study of sample Glidcop Al-15 Crotch Absorber. SEM images, (a) and (b): internal surface with detail of pitting. (c) EDS results reveals Copper, Oxygen and Aluminium as original components; also, Sulfur in the corroded areas is observed, as well as Carbon and Silver in some regions.

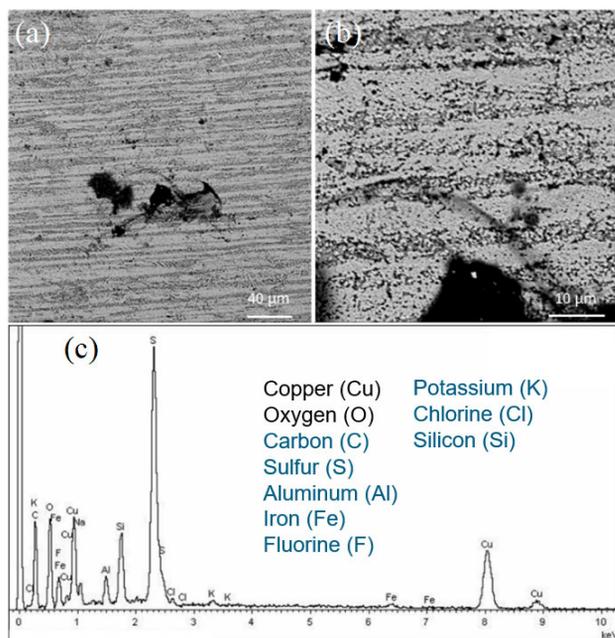
The samples S6, S7, S8 and S9 show pitting corrosion on their interior surfaces, with the presence of Cl⁻ ions in some of their semi-quantitative EDS composition spectra. The samples S6 and S7 show generalized corrosion on their inner surface, in the form of a dark-colored oxide layer. The samples S8 and S9 did not show the presence of a homogeneous oxide layer, but rather signs of pitting and crevice corrosion, respectively (see example of Fig. 5a and 5b, sample S9). In some regions of samples S6, S7, S8 and S9 the EDS analysis has confirmed the presence of Copper

and Oxygen, as well as other minor elements of the different base metal compositions such as Sulfur, Silver, Carbon, Silicon and Iron (see example of Fig. 5c, sample S9). Likewise, other elements from circulating water such as Potassium and Chlorine have also been detected. The recurrent presence of Chlorine in the EDS spectra carried out on the corrosion oxides present in the samples S6, S7, S8 and S9, would establish a cause-effect relationship between the presence of chlorides in the circulating water and the action of pitting and crevice corrosion. The pit depth present in samples S6, S7, S8 and S9 is in the range between 1.82 and 119.4 μm and the XRD analysis of the oxidized surfaces has confirmed the presence of two crystalline copper oxide phases on the inner surfaces, a first phase corresponding to metallic copper (JCPDS 85-1326) and the second corresponding to standard copper oxide (JCPDS 48-1548).

Figure 5: Quadrupole sample (bent pipe). SEM results, (a) and (b): not generalized corrosion with presence of pits. (c) EDS spectra: presence of Copper, Oxygen, Potassium, Aluminium, Silicon, Iron, Carbon, Fluorine, Sulfur and Chlorine.

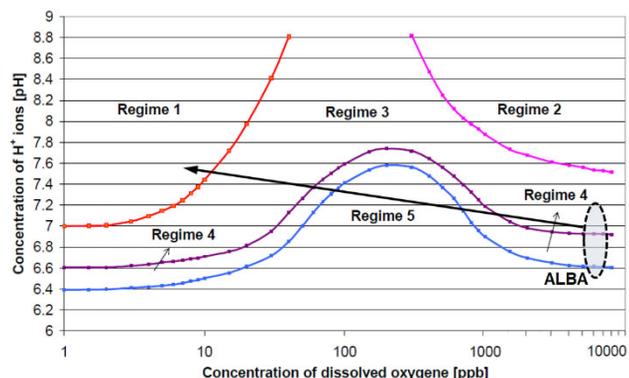
To minimise the effects of corrosion, there is a consensus solution applied by complex facilities: improve the quality of deionized water [3–9]. This alternative is represented in the experimental curve in Fig. 6. Depending on the combination of pH versus (DO) content, the copper components have different corrosion rates (regimes 1, 2, 3, 4 and 5). Regime 1 is the preferred option, where the water is characterized by having (DO) content values < 10 ppb and $\text{pH} > 7.5$. In the case of ALBA, due to the fact that the pH has varied irregularly during the last 10 years, is assumed the hydraulic system has operated in regimes 3, 4 and 5.

Figure 6: Copper corrosion rates. Regimes 1 and 2: < 0.1 $\mu\text{g}/(\text{cm}^2\text{y})$, regime 3: $0.1-0.4$ $\mu\text{g}/(\text{cm}^2\text{y})$, regime 4: $0.4-1$ $\mu\text{g}/(\text{cm}^2\text{y})$ and regime 5: > 1.0 $\mu\text{g}/(\text{cm}^2\text{y})$. According to historical data, ALBA has operated in regimes 3, 4 and 5. The optimization objective is to operate in regime 1.

For the future, the ALBA's objective is to operate in regime 1. It is planning to have an Oxygen Degassing Plant to reduce the current (DO) content from 6500 ppb to values below 10 ppb. This means an average reduction of corrosion rate by a factor of 5. But prior to this step we are investigating the causes of the very high values in (DO) content that we have, considering that by design our circuit is a hydraulic closed loop. For a closed system (assuming negligible oxygen ingress), the concentration of DO will approach zero because all DO will be consumed by the corrosion process. This does not occur at ALBA.
